Inspection report for the property at  
1234 Summer road, Someplace, Washington

This report is prepared exclusively for **John & Jane Doe**  
Inspected On: **05-25-2023**

**Inspected By:**

Jeff Hudson, Washington State License  
#24032951

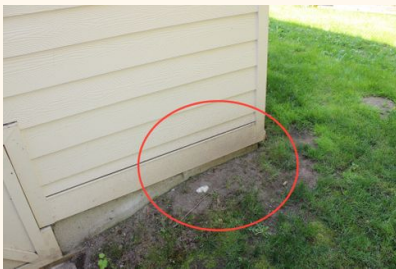
- Siding trim is in contact with the soil.
- Less than 6" clearance to soil.

*Less than 6" clearance to soil.*

**G1-1 Grounds:** Eliminate [wood /soil contact](#) to reduce the chances for rot and pest damage and repair any hidden rot as needed. Generally, a 6-inch clearance between soils and wood is recommended. Repairs should be made to get as much clearance as is possible and all contact with the soils should be eliminated.

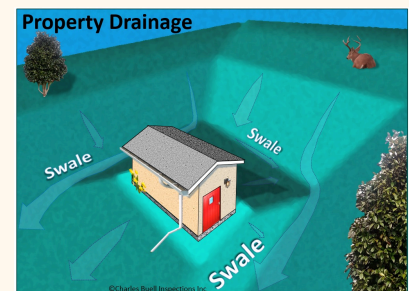
- The yard is sloping towards the house.

**G1-2 Grounds:** The [grade of the yard](#) is sloping toward the building. Standards recommend a quarter inch / foot slope away from the building or better to prevent water draining toward the house. Over time, negative grading, as this is often called, can lead to moisture and even structural problems with the house. Have this repaired as feasible by a qualified contractor. Often, a swale is used to create a low point away from the house into which water can be diverted away from and around the building.

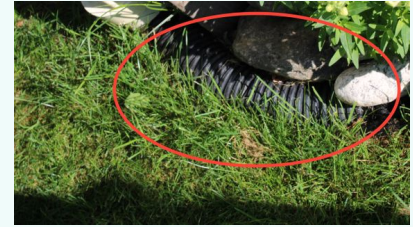
[Corrugated storm drain pipe](#) appears to be used for sub-surface drainage work to divert roof runoff away from the building. This product is prone to failure as it is susceptible to crushing and clogging. No evidence was found during inspection that these drains are backing up and require repair. Monitor during heavy rains to ensure roof runoff is being reliably carried away from the structure.

*Corrugated drain lines used for roof runoff - these are vulnerable to clogging and crushing.*

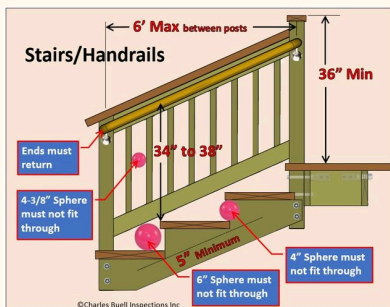
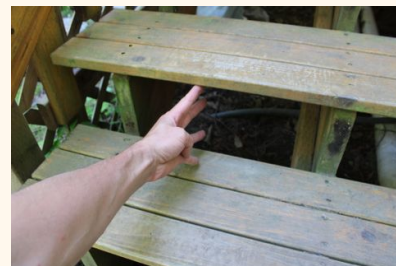
- Openings between stair treads more than 4".

*Openings between stair treads more than 4".*

**G1-4 Grounds:** The rear deck stairs have openings between the treads that are larger than 4-inches. This could be a safety hazard for children. Standards recommend openings in stair treads similar to guardrails - no more than 4 inches. Have this further investigated and repaired by a qualified general contractor.

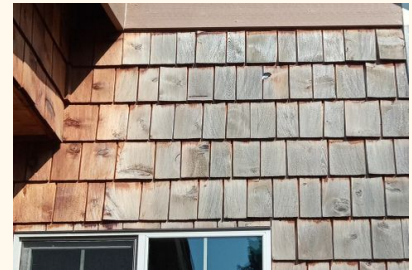
- Staining needed.

**ESDW-2 Exterior Siding, Doors and Windows:** The cedar shingle siding on this home is weathering and requires a new stain job to better protect the shingles and preserve the nice cedar color of the shingles. As cedar has a natural resistance to decay you can let the shingles go and turn a silver color. This will not immediately damage the shingles but this lack of treatment will desiccate the shingles leading to a more rapid deterioration of the wood as dried shingles are more prone to cupping and splitting. I recommend hiring a licensed painter to clean and re-stain the

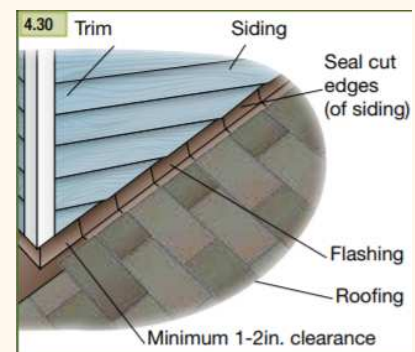
Inadequate clearances were noted between the roof and the siding. A 2 inch air gap is recommended here to keep the siding off the roof and prevent deterioration of the siding. This installation should be accompanied by step flashings that adequately protect the wall and roof juncture from leaks. Hire a licensed general contractor to further evaluate and repair this condition.

- Siding too close to roof.

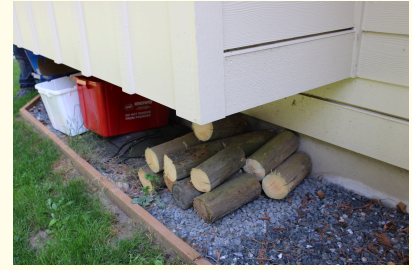
Storing wood next to the house creates a conducive environment for wood destroying organisms. (Think of it as an appetizer before the main dish for insects that enjoy eating or chewing wood). I recommend finding another location away from the house to store any wood materials.

*Wood pile next to house.*

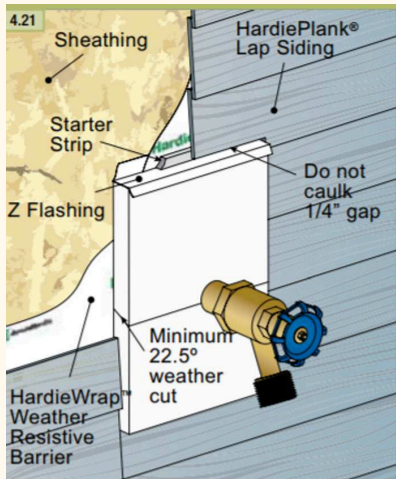
*Penetrations in siding greater than 1.5 inches should have a flashed mounting block*

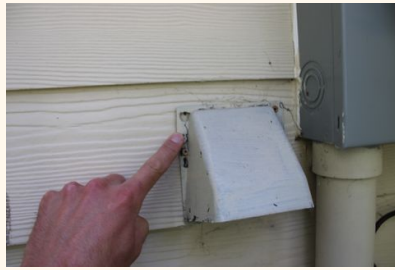
*Cracked dryer vent termination with no mounting block.*

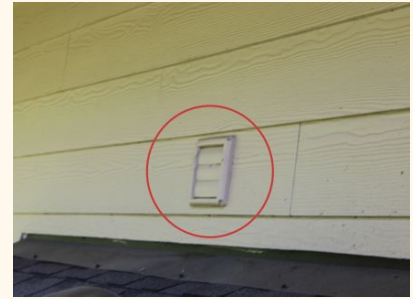
*No mounting block.*

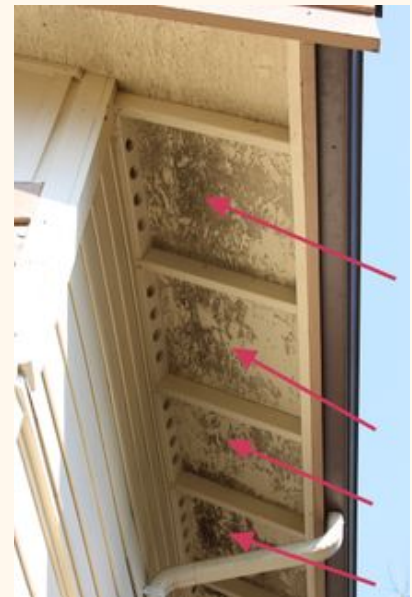
*Examples of mildew on eaves.*

**ESDW-7 Exterior Siding, Doors and Windows:** A bacterial or fungal bloom or mildew was noted on the eaves indicating the eaves need to be cleaned and re-painted for a proper finish. This house is located in a marine environment and surrounded by relatively dense tall trees and heavy vegetation. Heavier moisture laden air in the environment around this house will tend to stagnate and be drawn to collect on surfaces like the eaves creating a conducive environment for bacteria or mildew. When re-painting be sure to use a mildew-resistant paint on the eaves to help control this condition.

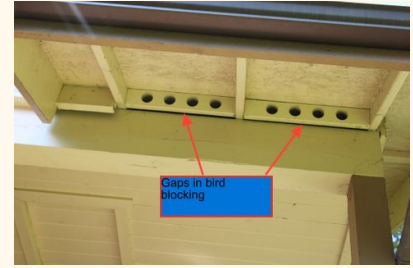
Examples of repairs needed to bird blocking.

**ESDW-8 Exterior Siding, Doors and Windows:** Bird blocking in the eaves requires repair to ensure adequate roof cavity ventilation and adequate bird, rodent and insect proofing. I recommend hiring a licensed general contractor to evaluate and make repairs.

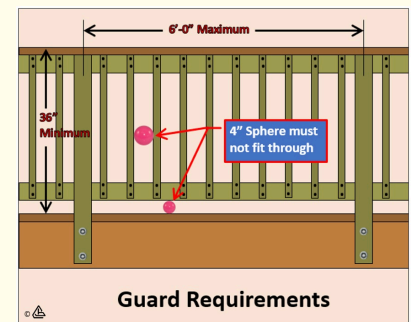
- The guardrail openings are larger than the 4-inches recommended today. This can pose a safety hazard for small children.

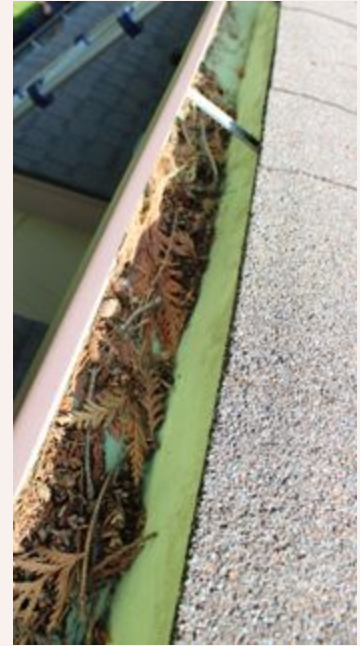
*Debris in gutter.*

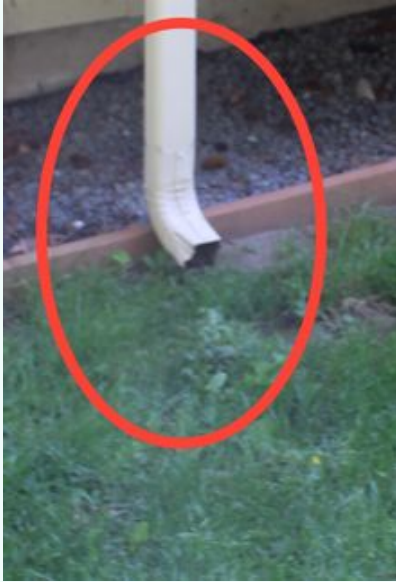
👁️ **(RCG-4) Monitor:** One of the gutter downspouts is not connected to a drainage system and is just draining into the yard. This particular downspout is connected to a very short gutter that is capturing water off a very small independent section of the roof. I would not expect much water to be discharged from this downspout. It would be best if this downspout was connected to the same drainage system as the other downspouts. If that is not possible, I would recommend adding a downspout extension to avoid the potential of water pooling near the foundation during a heavy or prolonged rain event.

*Downspout draining into yard.*

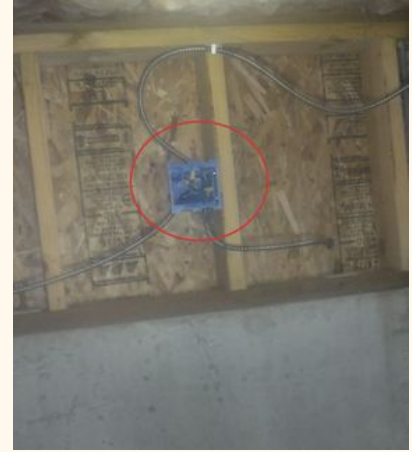
*Open electrical junction box under house in crawl space.*

**EDFW-2 Electric Distribution and Finish Wiring:** There is an open electrical junction box under the house in the crawl space. I recommend hiring a licensed electrical contractor to change the box to a surface mount or exposed type, typically metal, and installing a cover plate.

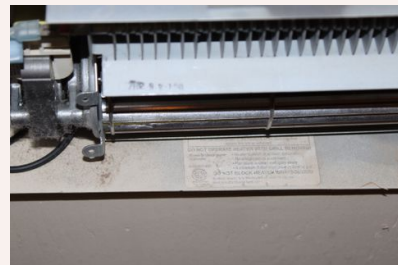
The electric wall heaters will require occasional cleaning - some of the heaters are showing signs of dust build-up. Best practices are to turn power off to the heater and use compressed air to clean the dust from the heating elements. The fan blades can be wiped or vacuumed as needed then restore power. Many manufacturers of these heaters recommend cleaning every six months to prevent a [fire hazard](#). They also recommend keeping all electric cords, curtains and furniture at least three feet from the heater.

Typical dust in electric wall heater.

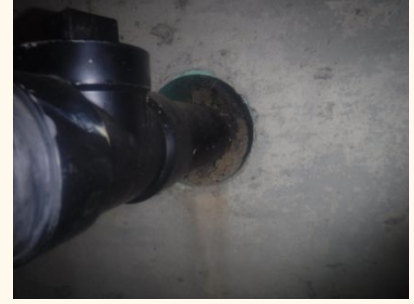
- Stains around this penetration indicate likely past leakage

*Sewer line not sleeved through foundation.*

🔧 **P-5 Plumbing:** The sewer line pipe has not been properly sleeved as it passes through the concrete foundation. Standards recommend a sleeve through the foundation wall and then sealing the pipe with spray foam as needed. Consult with a qualified general contractor to further evaluate and repair.

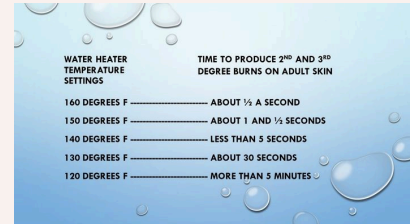
Testing of the plumbing system today, the water tested as too hot - 128 degrees F. This is a scald hazard. To prevent scalding, standards recommend indoor hot water temperatures do not exceed 120 degrees. There is some evidence that hot water temperatures should be greater than 130 degrees to prevent Legionnaires' disease from developing in the water heater. If this is a concern, you can heat the water in the tank to 140 degrees F and have a tempering valve installed at the hot water tank. Have this further evaluated and repaired by a licensed plumber, or simply turn down the temperature as desired to eliminate a scald hazard. Please note that during the inspection, it is difficult to accurately test the water temperature as it can vary between fixtures. Testing is done in multiple locations during the inspection, and a median temperature is taken.

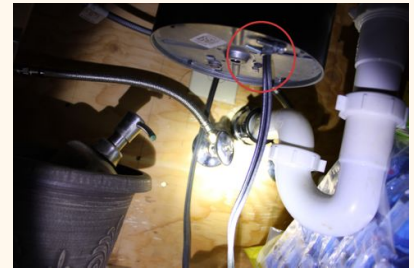
I could not determine if the garbage disposal has a required ground wire. There appears to be only two wires coming from the garbage disposal to the receptacle under the sink. I recommend having a licensed electrician evaluate this wiring.

*Garbage disposal under kitchen sink.*

🔧 **K-2 Kitchen:** I could not determine if the garbage disposal has a required ground wire. There appears to be only two wires coming from the garbage disposal to the receptacle under the sink. I recommend having a licensed electrician evaluate this wiring.

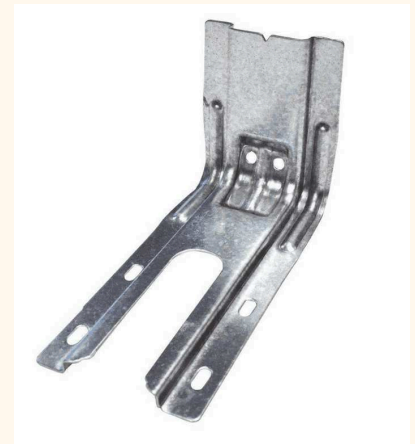
An anti-tip device is needed to prevent this range from tipping during operation of the oven door. This is a small clip that secured the back adjustable feet of the range to the floor.

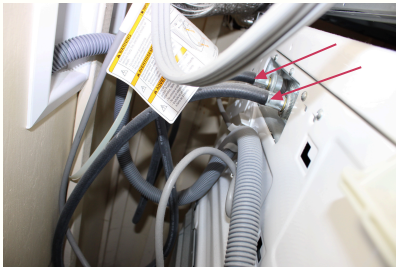
✦ (LF-4) **Note:** Older style rubber hoses are being used to supply hot and cold water to the washing machine. Over time rubber hoses can deteriorate and leak or rupture. I recommend upgrading to a much more durable braided stainless steel hose.

*I would consider updating these rubber hoses to braided steel.*

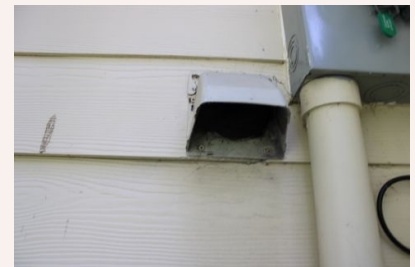
The dryer exhaust ductwork is dirty and needs to be cleaned for improved safety. This is important, regular maintenance to eliminate a potential fire hazard.

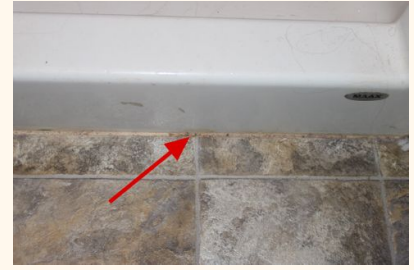
*Caulking between bath tub and floor*

🔧 **FB-3 Family Bathroom:** Caulking between the bathtub and the floor in the family bathroom needs repair to prevent water from damaging the floor. I recommend removing any existing caulking, thoroughly cleaning and drying the area between the bath tub and the floor, and installing a mildew resistant caulking.

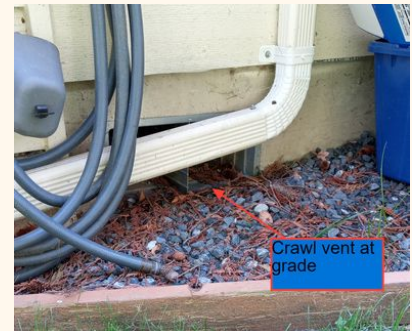
*Crawl vent at grade.*

🔧 **CS-5 Crawl Space:** Some of the crawl space vents have been installed at grade. The risk here is water entry into the vents. I recommend correcting the grade so water cannot flow into the vents. Often, digging a small well around the vents can help.

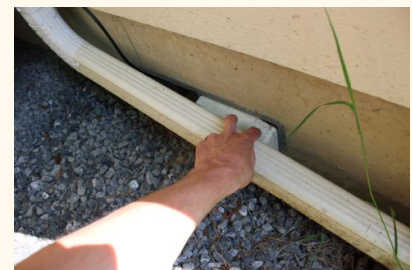
*Blocked vent.*

🔧 **CS-7 Crawl Space:** The crawl space vents are currently blocked by insulation in places. This seems intentional and is often done in colder and dryer climate zones in the winter as a means of improving interior comfort. In this climate zone, keeping crawl space vents open all winter is critical for keeping a dry crawl space. Implement repairs as needed to ensure vents are unobstructed. Use cardboard baffles to hold insulation up away from the vents.

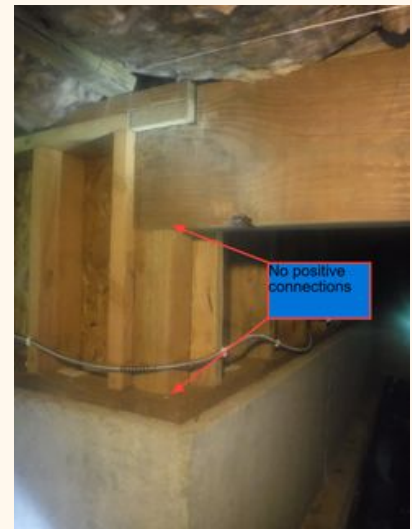
No positive connections between posts and footings.

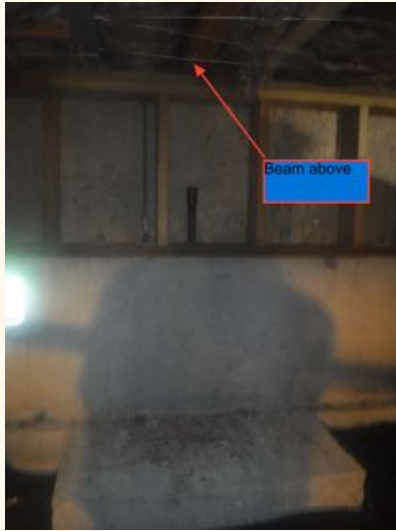
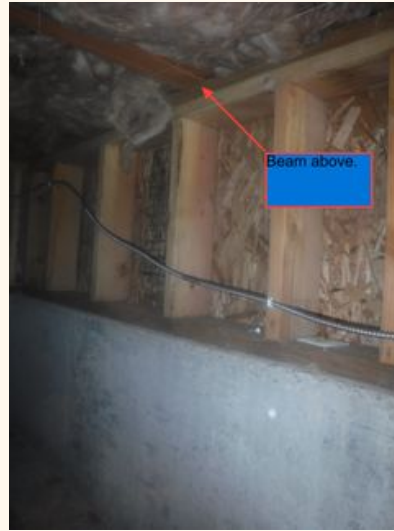
*Beams not properly supported.*

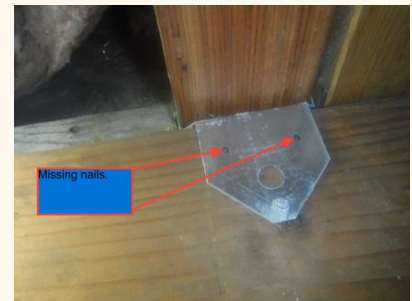
*Missing nails in bracket.*

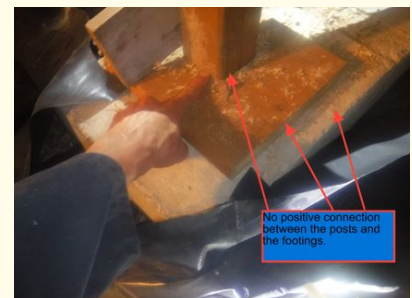
*No positive connections between posts and footings.*

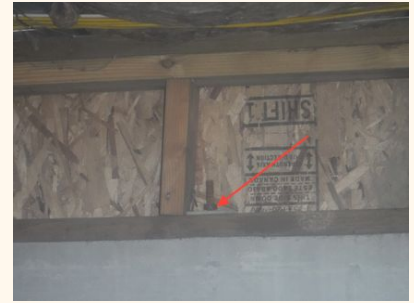
*Loose nuts on foundation bolts.*

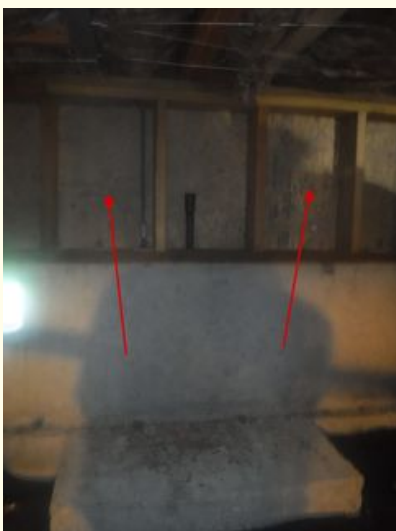
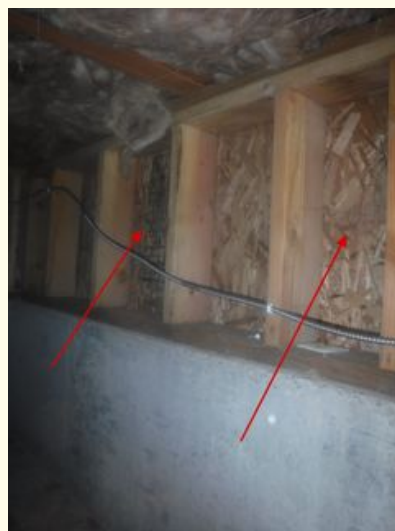
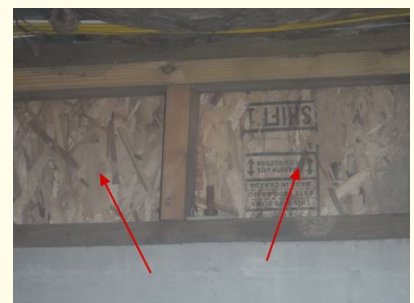
*Uninsulated wall framing.*

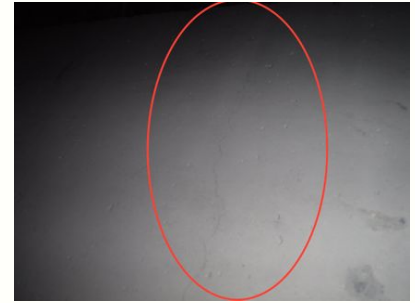
- No repair seems needed at this time. These look like typical cracks in foundations of this age.

Small crack.
