Inspection report for the property at  
1234 Summer road, Someplace, Washington

This report is prepared exclusively for **John & Jane Doe**  
Inspected On: **05-25-2023**

**Inspected By:**

Jeff Hudson, Washington State License  
#24032951

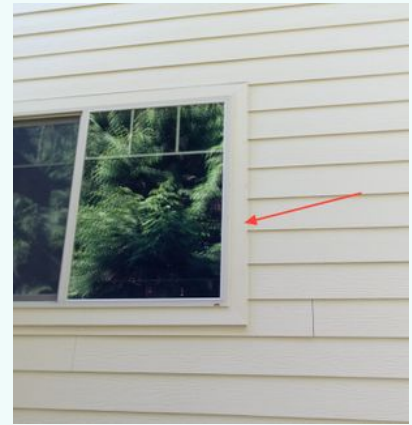
This house is trimmed with a softwood spruce trim. This wood is not especially resistant to wood decay. I would monitor the sun-exposed sides of the house. Try and keep the wood well-caulked and painted. Over time, expect the need for localized rot repair with this wood.

*Spruce trim.*

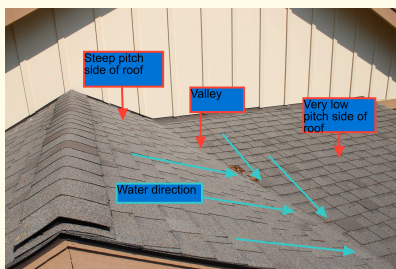
**🏠 (RCG-1) Improve:** This roofing system has a [woven valley detail](#). These can be more vulnerable to leaks over time than metal valleys. Most shingle manufacturers seem to allow this detail, especially with lighter weight shingles. It is usually not possible to identify the shingle manufacturer during a home inspection. Metal valley details are generally preferable, but woven valleys are typically only listed as a defect if signs of excessive wear or failure are noted during this visual inspection. This particular use of a woven valley is one of the least advisable situations. As the water runs towards the valley from the steep pitched side of the roof, there is virtually nothing to divert the water from trying to go under the shingles on the very low pitched side of the roof. Ideally there would be a metal flashing with a raised diverter section installed in the valley between the different sides of the roof. I recommend hiring a roofing contractor to evaluate and add a metal valley flashing.

*Direction of water runoff towards valley.*

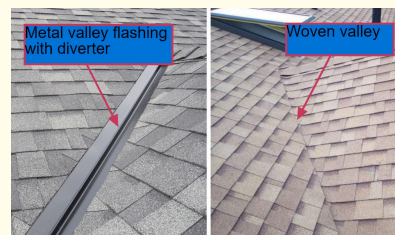
*Examples of metal valley flashing and woven valley.*

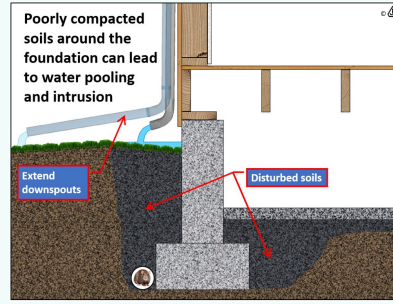
*Downspout extension.*

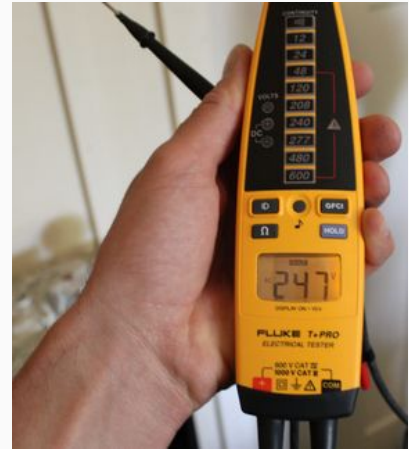
The tested voltage at the electric panel today was 247 volts. Most residential construction is listed as 120/240 volts. Slight fluctuation is normal.

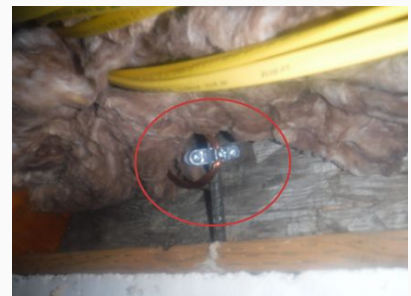
A UFER ground connection was noted for the electrical grounding system. These are required and standard on newer construction houses. These grounds connect the electrical system to Rebar in the house foundation and make a reliable path to the earth for "earthing" or grounding the electrical system.

*UFER ground under house.*

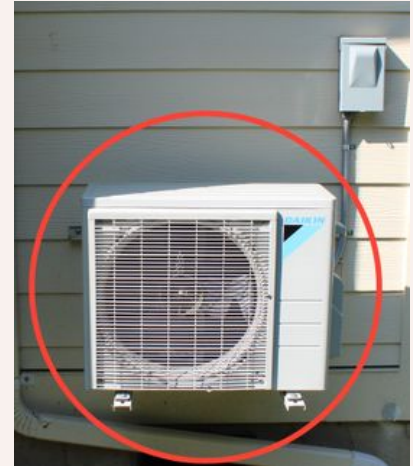
I recommend keeping the ductless heat pump system on a [routine service schedule](#). These systems should be cleaned and serviced annually for efficient operation and to prolong the useful service life of this equipment. The average life of a heat pump is 15-20 years. This system was operating as intended during inspection.

*Ductless heat pump outdoor unit.*

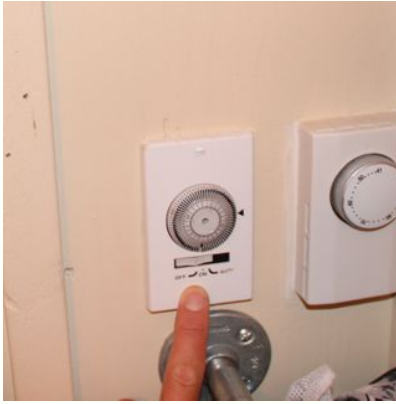
Whole house exhaust fan timer.

**(HCFV-10) Note:** This house has a timer for a whole house fan. Unfortunately, most home owners and renters do not fully understand how these timers are actually supposed to be used. These timers are designed to make a fan come on periodically to exhaust interior air, facilitate air changes and help keep the indoor relative humidity in check. As a general rule, keep relative humidity around 50% in cold weather to reduce chances for condensation. For more information about whole house fans and setting the timer see: this [LINK](#).

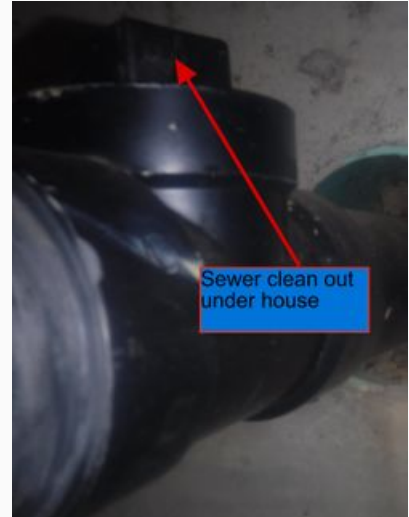
*Sewer clean out under house.*

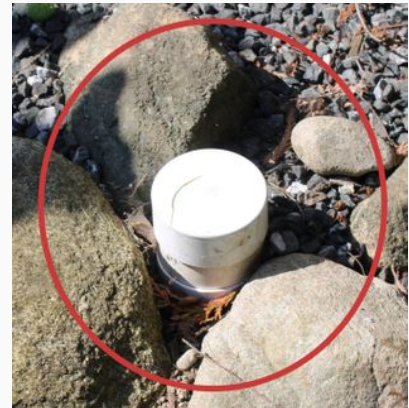
*Clean out in side yard.*

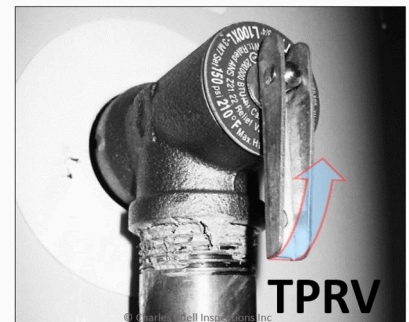
*The arrow shows how a TPRV can be tested*

Most codes defer to manufacturer instructions and I favor those recommendations. The yellow tag on the valve states clearly the termination should be 6" above the floor which is more consistent with the UPC code requirements.

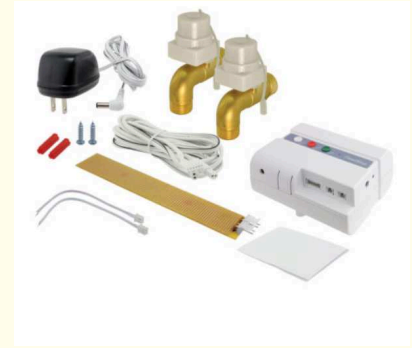
A moisture alarm with water shut-off features is recommended under the washing machine to protect against accidental leaks in the supply hoses. Pans can be effective when there is a drain, but even these will not protect against a burst supply connector. A moisture alarm with automatic shut-off will. Watts is a brand I have seen installed: [Link](#).

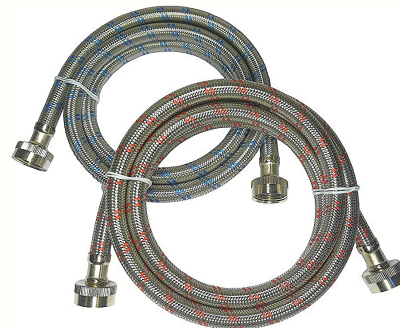
*I would consider updating these rubber hoses to braided steel.*

*Braided steel hoses.*

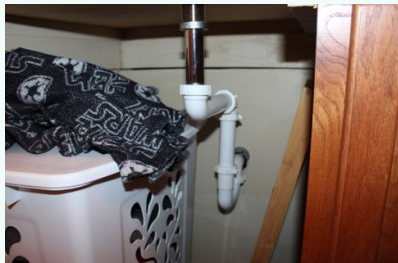
👁️ **(FB-1) Monitor:** The plumbing fixtures in the family bathroom are installed in a non standard way, but do appear to be functional and operating as intended. It is worth noting that typical

industry standards for installing plumbing fixtures are established to not only ensure functional operation but to help prevent potential damage to the fixtures and drains during normal usage that could allow water or sewage to leak into the house. Due to the extended exposed piping used, and how the extended piping appears to be supporting the fixtures, I recommend diligent monitoring of the sink plumbing fixtures as well as the extended waste lines under the sinks for any signs of leakage and have any suspected leaks evaluated and repaired by a licensed plumber right away.

*Waste line for bathroom sink.*

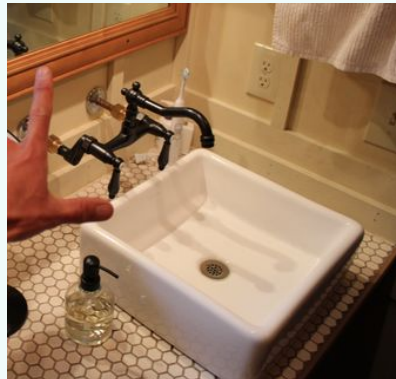
*Bathroom sink*

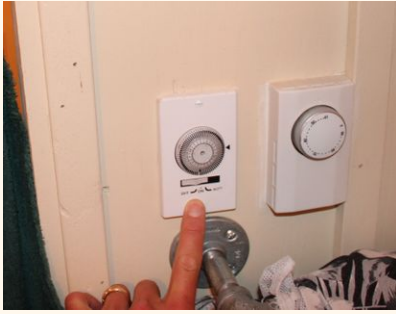
(FB-4) **Repair:** There is an exhaust fan and timer installed in the family bathroom. This serves as a whole house fan for the house and should be set to auto so that it will run periodically throughout the day based on the adjustable timer settings. To turn the exhaust fan on when using the bathroom, the timer has to be manually switched to on, and then later manually switched back to auto. This is not a reliable way to insure the whole house fan is being consistently used as intended. To solve the problem and make the exhaust fan work in both situations I recommend having a licensed electrician install a timer that can be programmed to operate the exhaust fan as a whole house fan periodically throughout the day, and can be temporarily over-ridden to run while the bathroom is being used with the push of a button. After a set amount of time, the override is cancelled, and the exhaust fan continues to run as a whole house fan.

*Whole house fan timer.*

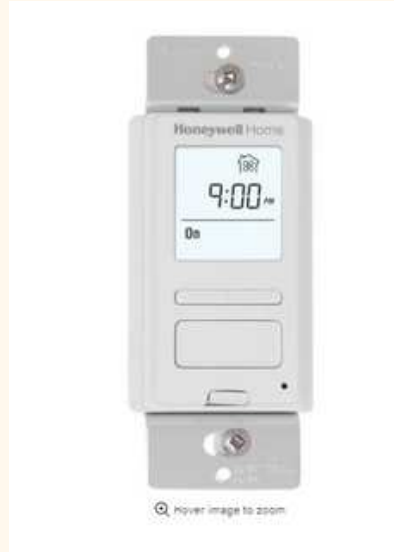
*Example of whole house timer with over-ride function.*

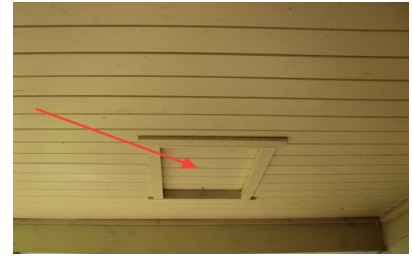
Attic access hatch above back deck.

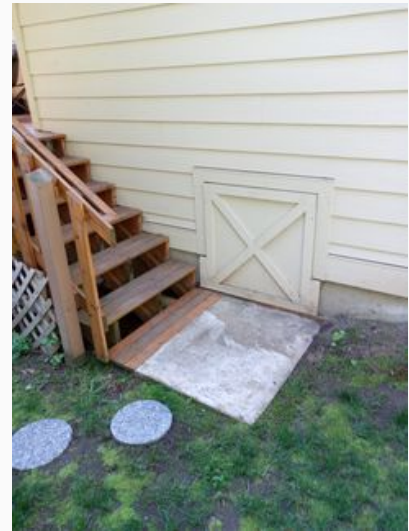
*Crawl space access at back of house.*

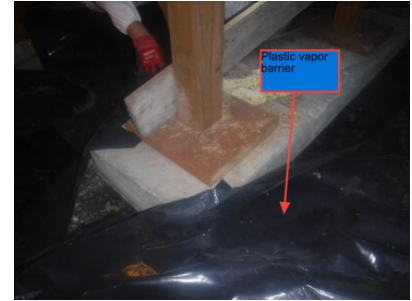
*Plastic vapor barrier in crawl space.*

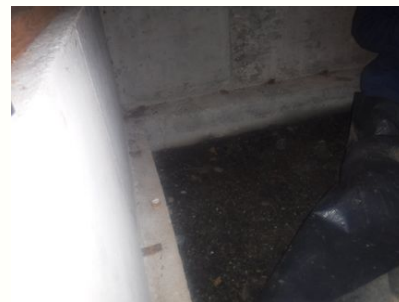
Gravel was used below the plastic vapor barrier in the crawl space. This is a nice practice - the gravel acts as a capillary break and can help prevent seasonal water from getting on top of the vapor barrier.

*Gravel installed under vapor barrier.*

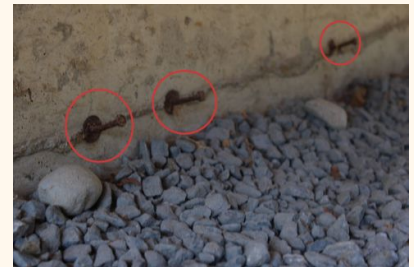
The metal form ties used to support the concrete foundation forms during construction of the foundation are protruding from the concrete in places and could pose a safety hazard. I recommend pounding down or grinding these off to eliminate a safety hazard.

*Metal form ties.*
